# Effective Conveyor Belt Inspection for Improved Mining Productivity

## Final Report

US Department of Energy  
Award #DE-FC26-04NT42086

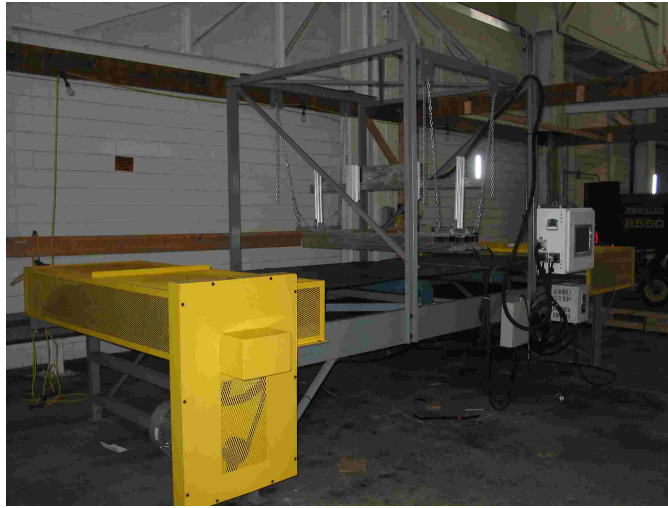
Figure 1: A full-sized test rig has been built and installed at NREC for testing and algorithm development.

An above-ground test system was fabricated in order to allow convenient testing and refinement of the mechanical splice detection prototype. The system includes a working conveyor belt of full 60-inch width, containing several mechanical splices. In addition, the belt contains two vulcanized splices for use in vulcanized splice detection algorithm development (see Section 3.4). The test system is shown in Figure 1.

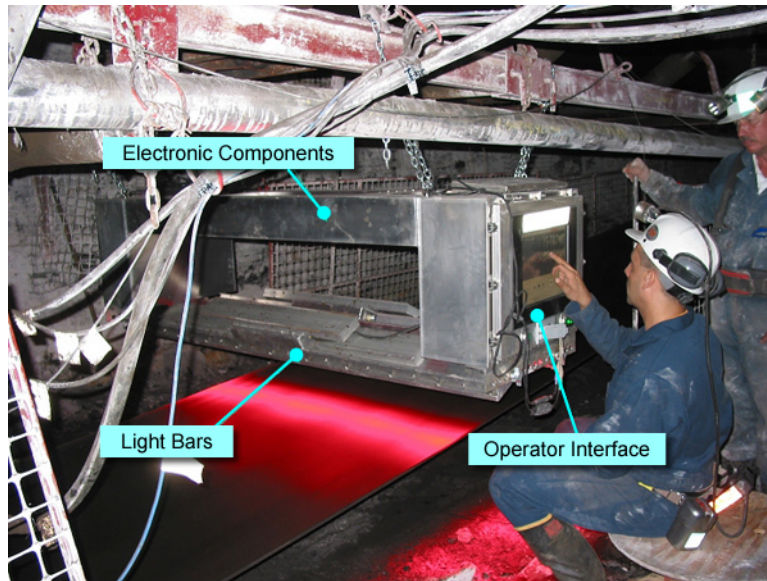
Figure 2: Original belt inspection prototype system installed in an underground coal mine.

The original belt inspection prototype system was a single, monolithic structure, involving custom fabrication and electronics assembly. This prototype is illustrated in Figure 2. This images shows the prototype in use at an underground coal mine near Blacksville, West Virginia.

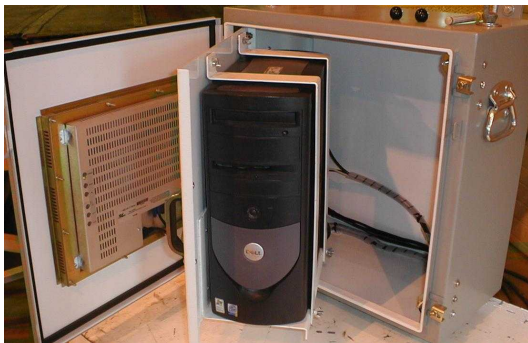
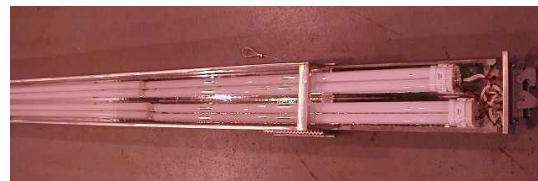
Figure 3: A reduced cost BeltVision prototype was designed in order to facilitate testing, marketing, and deployment. The new design is highly modular, permitting easy replacement of parts. Subfigure (a) shows inexpensive, off-the-shelf computing hardware in a protective enclosure, and Subfigure (b) shows a fluorescent lightbar assembly. Note that the fluorescent light bar was subsequently replaced by an LED based unit.

The low-cost prototype includes inexpensive off-the-shelf computing hardware and a redesigned lightbar. Figure 3 shows these components, along with the protective enclosure for the computing subsystem. As with the original BeltVision system, a touchscreen user interface is provided for convenient user interaction. This PC-based prototype system has several advantages over the original design, including greatly reduced cost, increased reliability, increased portability, and increased modularity in case of hardware failure. The primary limiting factor in portability of the PC-based prototype system is the length of the light bars, which are more easily transported in a minivan than in a sedan. PC-based BeltVision systems can be rapidly assembled and deployed, and were central to the success of the project.

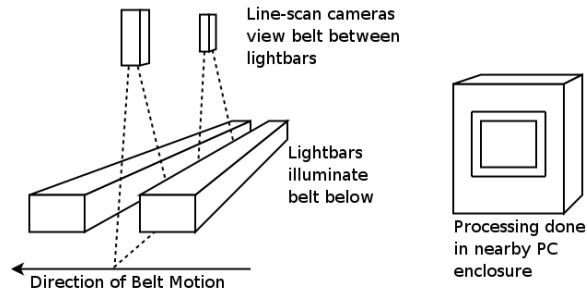
Figure 4: A schematic of the PC-based BeltVision system. For photos of the actual system, please refer to Figure 5.

Figure 4 shows a schematic of a PC-based BeltVision system, while Figure 5 shows one of these systems installed on an above-ground test belt. Each BeltVision system includes a pair of

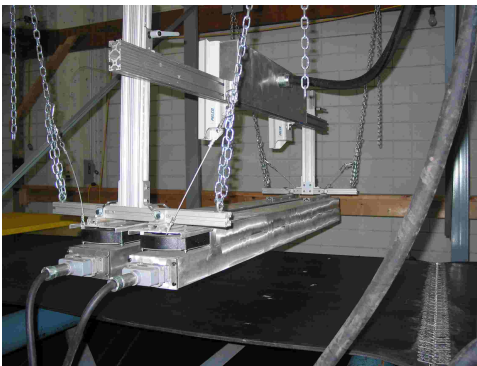
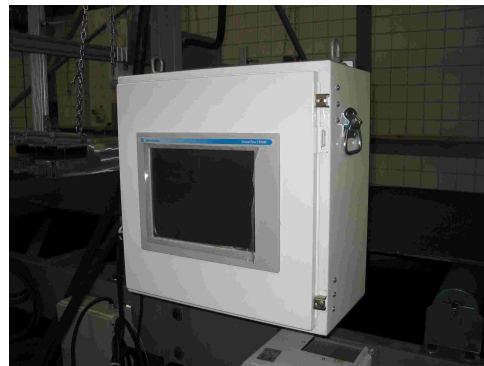
Figure 5: The PC-based BeltVision system includes two lightbars which illuminate the belt as it passes underneath the system. A pair of line-scan cameras acquire images of the belt, while processing of the acquired image data is performed in a nearby enclosure containing a commercial PC computer.

synchronized high-speed high-resolution line-scan cameras mounted side-by-side so that the output from the two cameras can be concatenated to approximate a single scan-line. The BeltVision system is positioned in such a way that the direction of belt travel is perpendicular to the camera scan-line. As the belt moves under the cameras, successive scan lines are assembled into 2D images as shown in Figure 6. These images are saved to hard disk and provide a high-resolution record of the belt surface. The approximate resolution of the surface image is 50 pixels/inch.

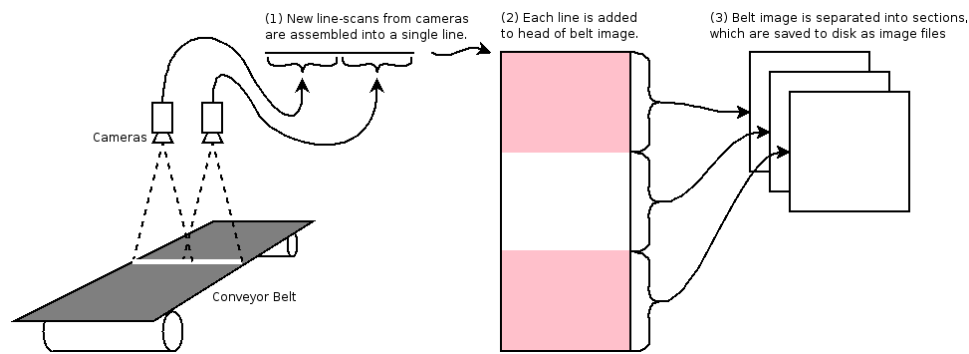
Figure 6: Individual scanlines are assembled into 2D images, which are saved to disk.

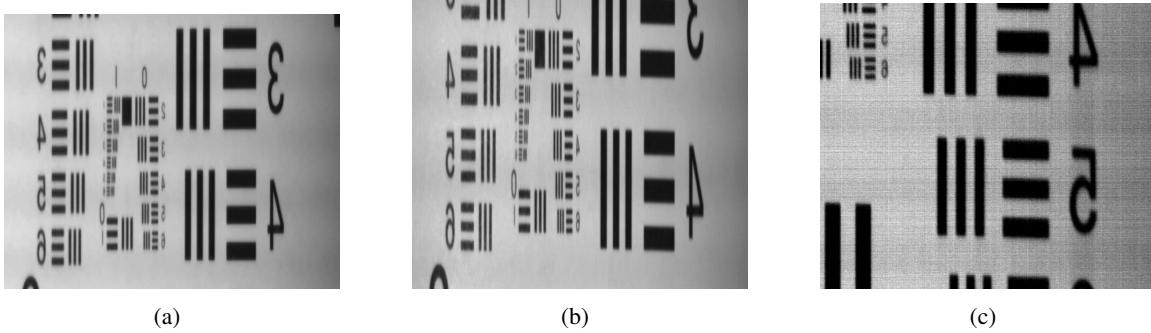
Figure 7: Several different line-scan sensing elements were evaluated: (a) shows an image from a Dalsa CCD-based line-scan element; (b) shows a similar image from a Perkin-Elmer CCD-based line-scan element which is significantly less expensive; and (c) shows an image from a CMOS line-scan element, which was even less expensive, but which was found to have inadequate image quality.

A low cost imaging specification document was generated in order to guide selection of appropriate sensing and computational elements, and commercially available line-scan imaging elements were evaluated. Figure 7 shows sample images from several such sensing elements. A final down-select was made to a Smart Camera design based on CCD linescan element manufactured by Perkin-Elmer, an Altera FPGA and a Motorola Coldfire CPU. The overall architecture of the Smart Camera is illustrated in Figure 8. This design is based on feedback from potential users and mining experts, and strikes a good balance of functionality and overall system cost.

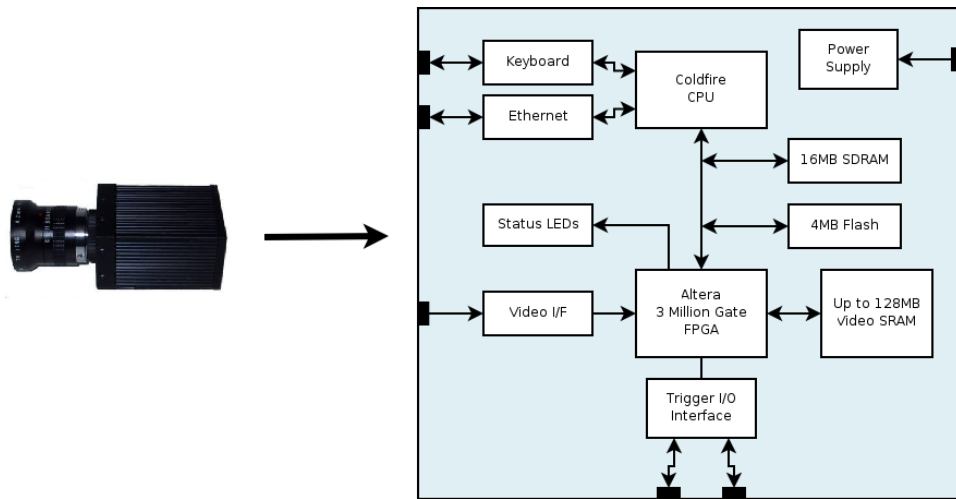
Figure 8: Overview of the initial low-cost Smart Camera system design. This illustration shows the sensor element integrated with the camera housing. In the final system, the sensor (a line-scan CCD array) is housed separately in a remotely attached sensor head, so that multiple CCDs can be driven by a single Smart Camera.

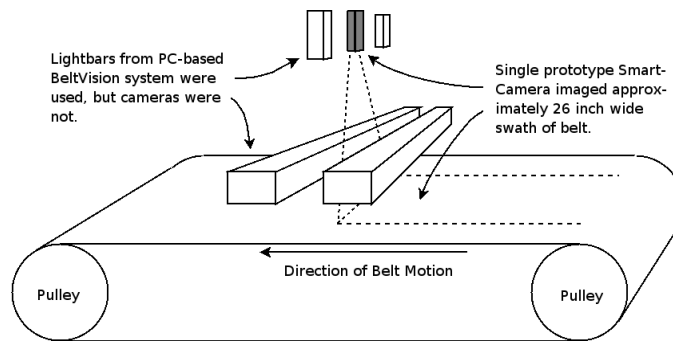
Figure 9: A schematic showing the mounting position of the Smart Camera prototype during the proof of concept demonstration.

Both a PC-based BeltVision System and the prototype Smart Camera were attached an the above-ground test rig. The Smart Camera was mounted mid-way between the positions of the two cameras in the PC-based system, and oriented so that its scan line imaged approximately 26 inches of belt between the two lightbars. In order to visualize this setup more clearly, please refer to Figure 9. The test rig was very similar to the one shown in Figure 1, and had a short (approximately 20 meter) length of belt containing several mechanical splices. When the motor drive was activated, the belt moved under the mounted BeltVision unit, simulating the motion of the much longer belts at the mine installation sites.

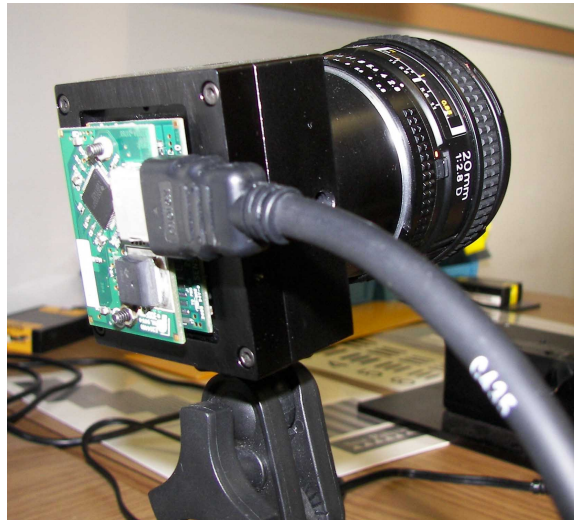
Figure 10: A partially assembled camera head for the Smart Camera based BeltVision system.

Housings for the camera-head assemblies were designed, and camera-head enclosures were fabricated. Figure 10 shows a camera head with its back cover removed, and with sensing element and I/O board installed. These camera heads will replace the expensive commercial line-scan cameras in the current BeltVision prototype, and connect to the FPGA housing using an inexpensive HDMI cable.

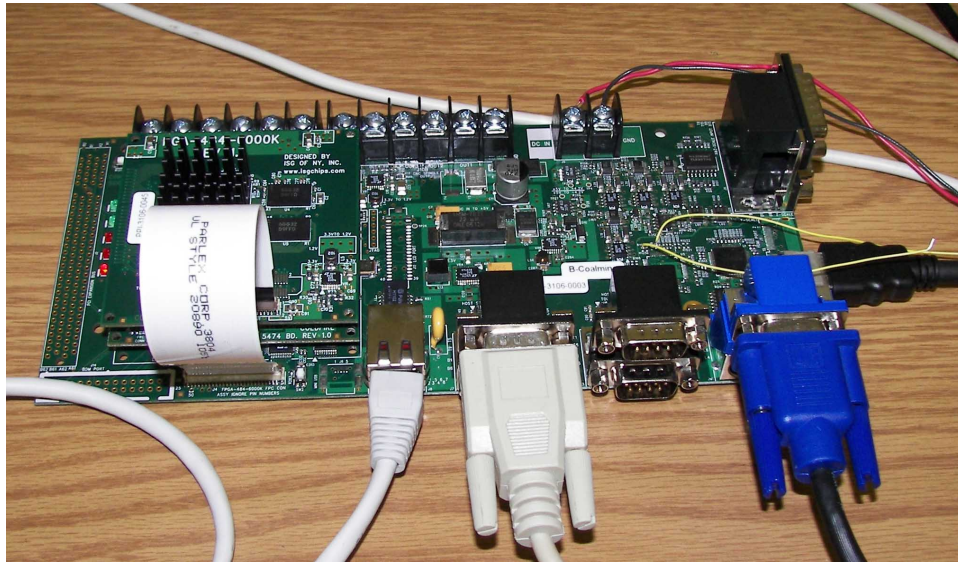
Figure 11: A fully functional computing board for the Smart Camera, photographed during demonstration in September, 2006.

A photo of a fully assembled and functional FPGA board is shown in Figure 11.

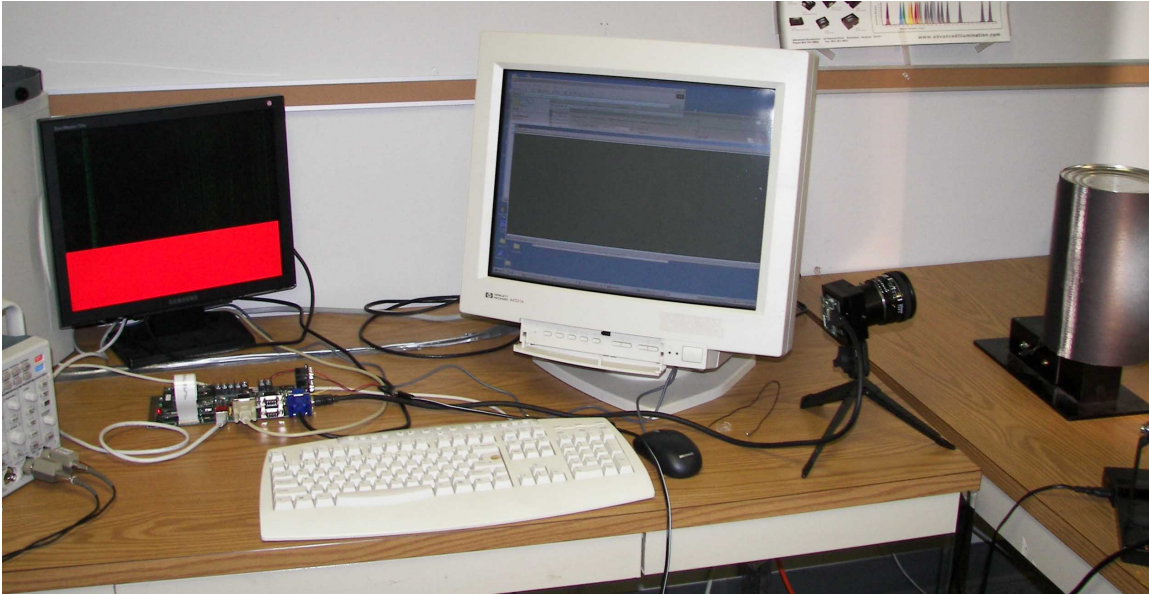
Figure 12: A bench test of a single-headed Smart Camera system was conducted in late 2006.

The system was bench tested in September, 2006. Camera input was simulated by moving pictures of mechanical splices past a single sensor head, and splice detector functionality was monitored via PC, as shown in Figure 12. Internal software diagnostics indicated correct functioning of

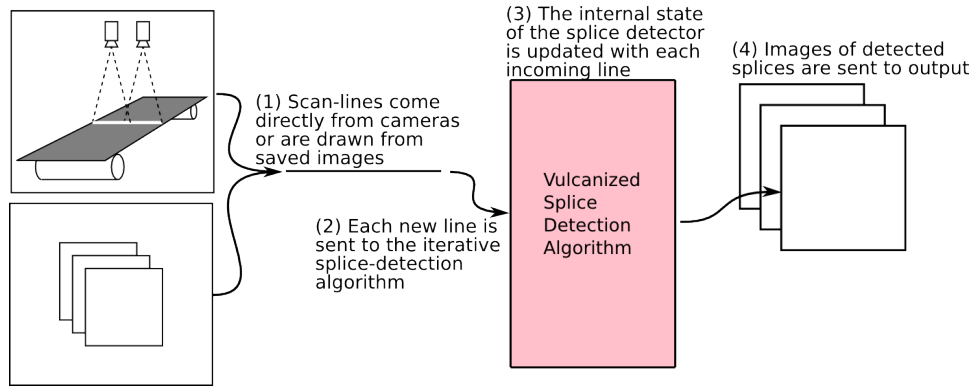
Figure 13: The vulcanized splice detector allows incremental processing of image data. In the current installations, direct connection between the cameras and the vulcanized splice detection software is not implemented. Instead, splice detection is automatically performed twice a day using images which have been saved to hard disk. as shown in Figure 6.

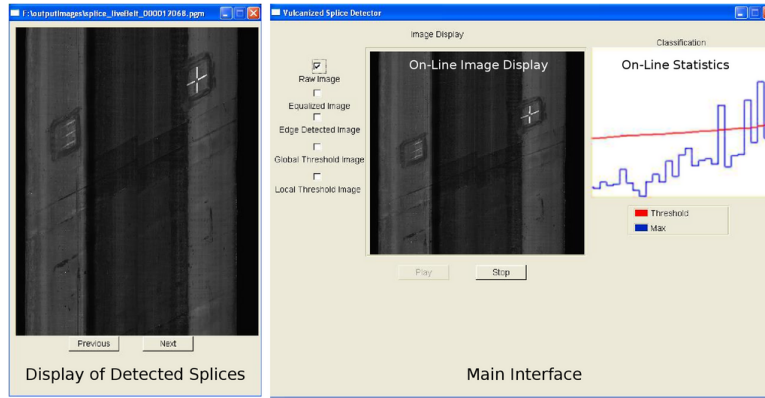
Figure 14: A screenshot of the GUI-based vulcanized splice detection application under development. Note that the inclusion of white fiducial markings in the neighborhood of vulcanized splices is very rare: the white cross visible in the screenshot is highly unusual.

Figure 14 shows a graphical user interface used to monitor algorithm performance during early development. Note that in actual use, the algorithm runs unattended, with no GUI, and simply saves its results to disk.

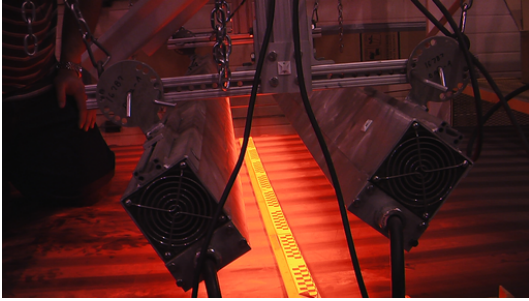
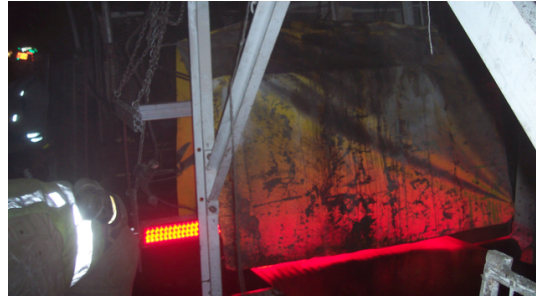
Figure 15: (a) The original lighting configuration, using two light bars, deployed at Beitzel Corporation's above-ground test facility. The photograph is taken from beside the belt, looking perpendicular to the direction of belt travel, along the length of the light bars. A yellow calibration target is lying across the width of the belt. (b) The revised, single-light-bar configuration deployed underground. The light bar is partially obscured by a piece of brattice cloth, with the LED light emitting surface facing the camera. The brattice cloth curtain significantly reduces fouling of the cameras and light bar.

During most of the project period of performance, the belt inspection system system included two LED light bars, suspended above the belt, one upstream of the cameras, and one downstream of the cameras, as shown in Figure 15(a). Subsequent testing has shown that splice recognition accuracy for both mechanical and vulcanized splice detection algorithms can be maintained using only one light bar positioned an oblique angle as shown in Figure 15(b). From this angle, the light highlights surface detail on the belt, in some cases improving system performance. This change is significant

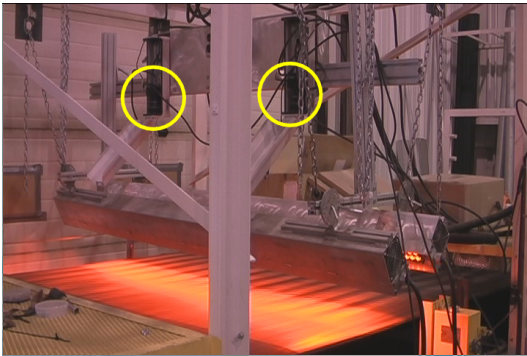
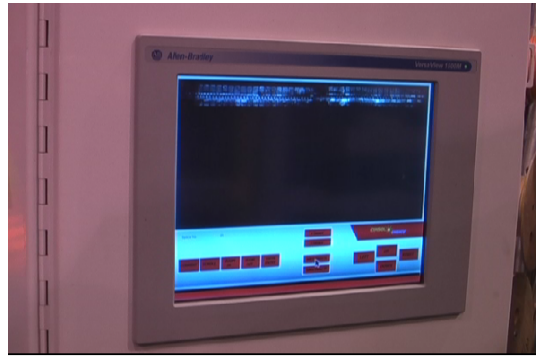
Figure 16: (a) The two-headed Smart Camera under test at the above-ground test facility. A conveyor belt passes underneath two LED light bars. The two yellow circles indicate the new camera heads, which are considerably smaller and less expensive than the Dalsa units that were previously used. (b) An LCD screen being driven by the Smart Camera. The top of the screen shows an image of the most recently detected mechanical splice, while the bottom of the screen shows an GUI overlay that can be manipulated via touchscreen.

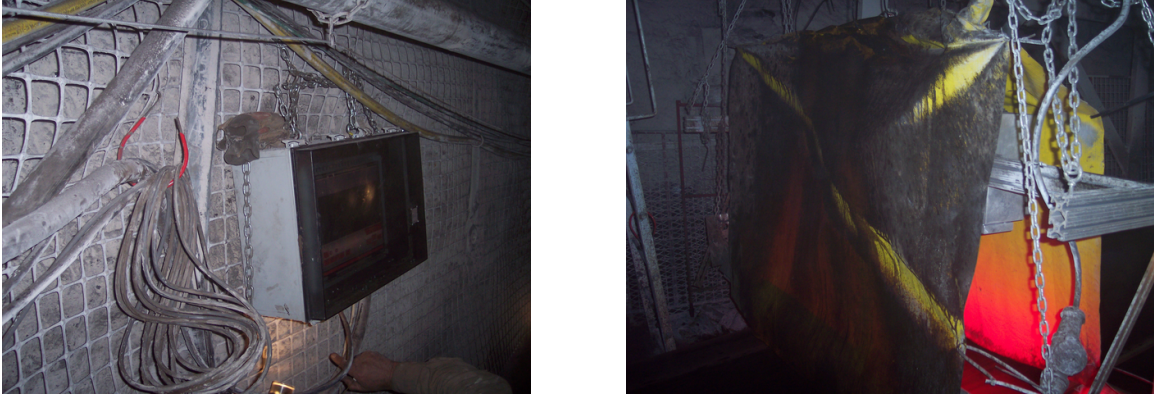
Figure 17: (a) The Smart Camera main board installed in wall-mounted enclosure in the Bailey mine for testing. The transparent cover of the enclosure folds down to allow access to an LCD touchscreen. The cover can be closed to protect the touchscreen without obscuring the display. (b) The light bar and two camera heads are suspended above the belt on an aluminum frame. This picture was taken on an operating belt, and the assembly is partially obscured by brattice cloth, which greatly reduces fouling of the cameras and light bar cover.

The Smart Camera system is currently undergoing shake-out testing in preparation for initial low volume marketing. Figure 17 shows the fully packaged prototype as deployed in the Bailey mine, near Bailey, West Virginia.

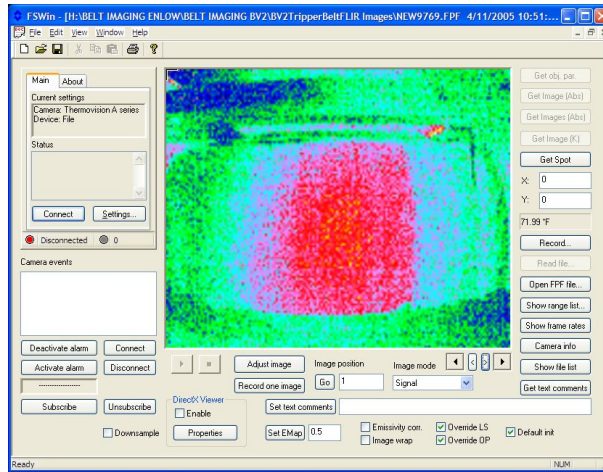
Figure 18: The thermographic imaging interface during acquisition of footage from the Blacksville mine.

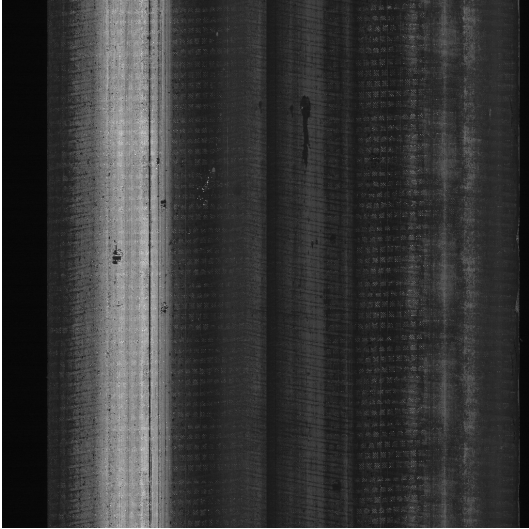
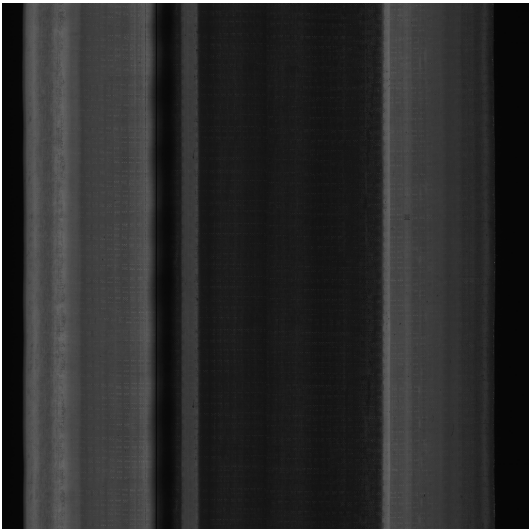
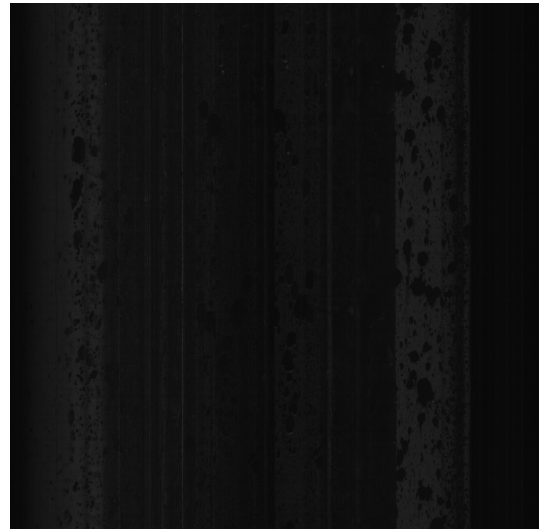
Figure 19: Raw images from each of the four tested installation sites.

The images from each mine were observed to have different character, depending on both the specific belt and the environmental conditions of the installation site. Reduced resolution images from four installation sites are shown in Figure 19. All four of the images in this figure have vertical

banding, which is characteristic of all of the belts we have observed. Of particular interest are the diagonal lines introduced by pulley lagging in the images from the Bailey mine, since these lines are easily mistaken for vulcanized splices. Also of interest is large amount of noise in the Robinson Run images due to mud and water on the belt. In order to show these phenomena more clearly, sections from both the Bailey image and the Robinson Run image are shown at higher magnification in Figure 20. The contrast of each of the images in this Figure has been increased somewhat to provide a clearer view of the belt detail.

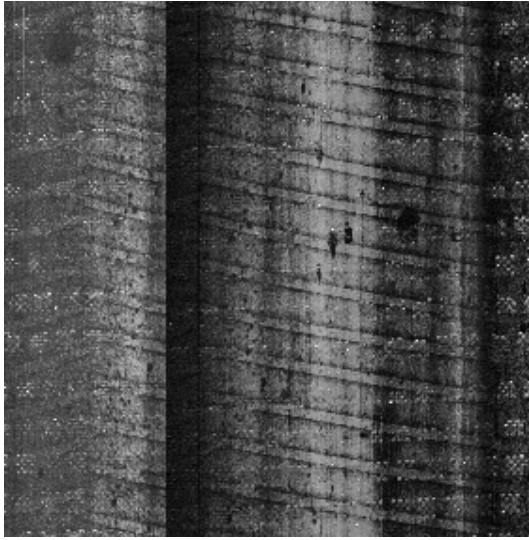
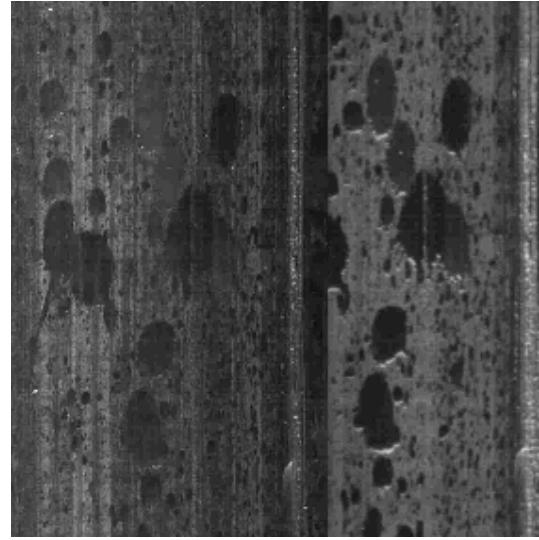
Figure 20: Sections of the images from the Bailey Mine and Robinson Run Mine. The contrast of these images has been increased somewhat to permit easy viewing. Pulley lagging in the Bailey mine image leaves an impression on the belt which is easily mistaken for the diagonal line of a vulcanized splice.

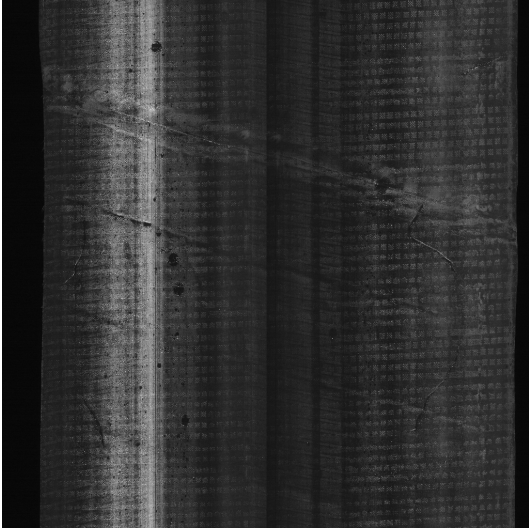
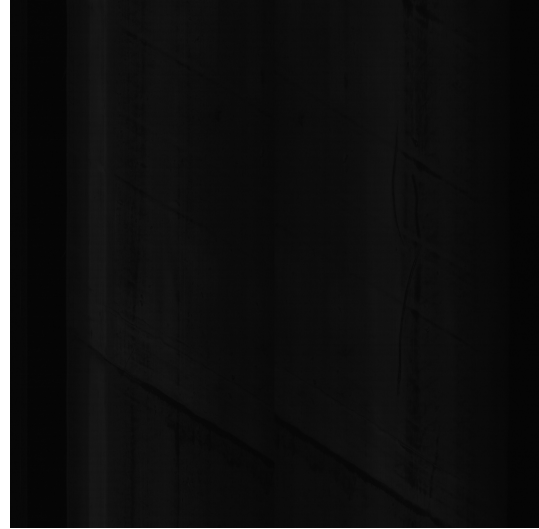
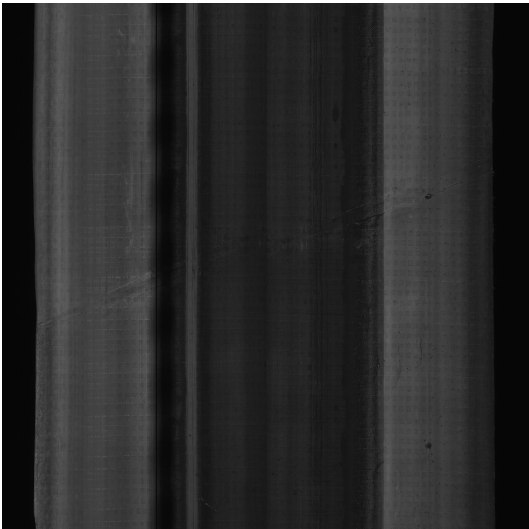
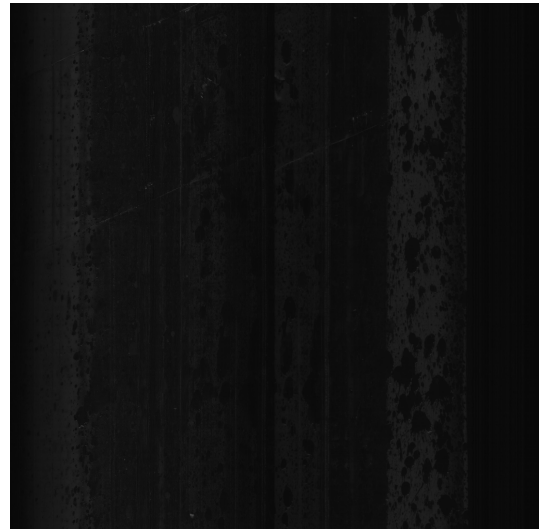
Figure 21: Representative splice images from each of the four tested installation sites.

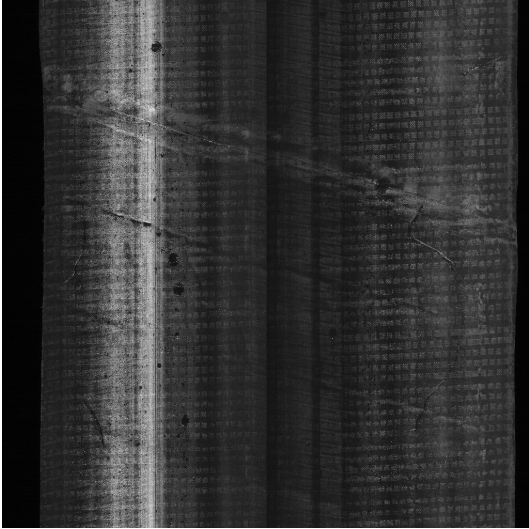
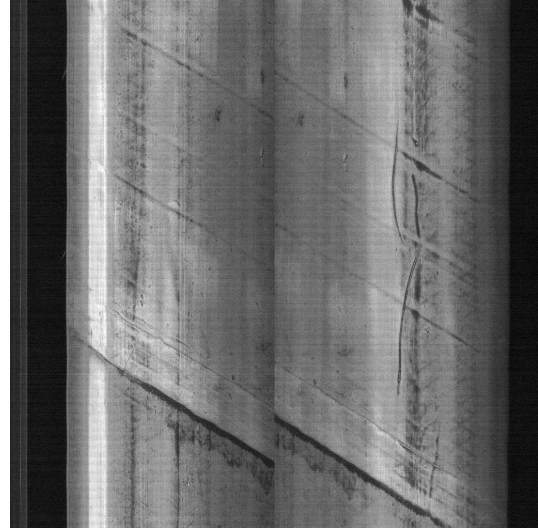
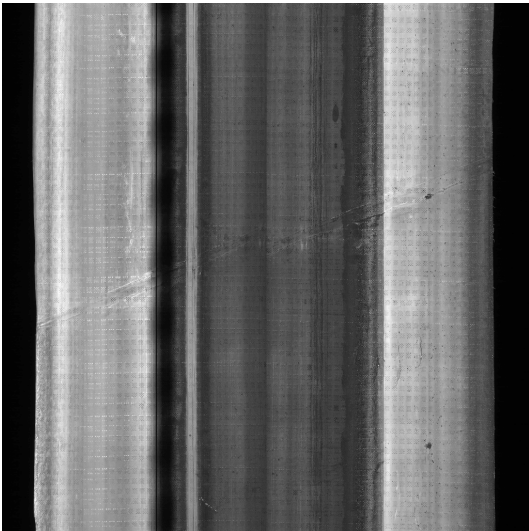
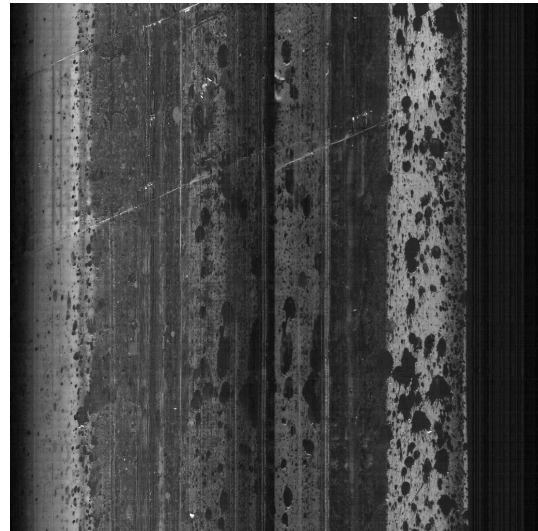
Figure 22: These are the same images as shown in Figure 21, except that the contrast of each image has been adjusted to make the splice more easily visible. The Bailey Mine image is not visibly changed because the original image has very high contrast.

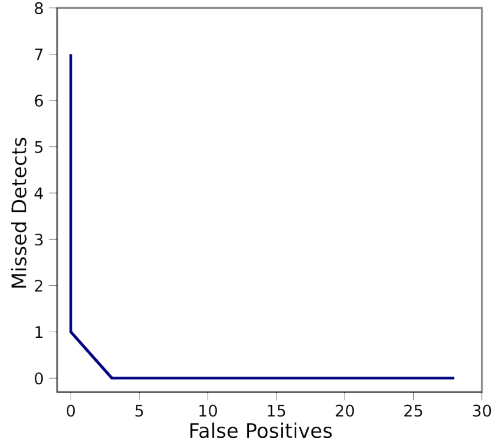
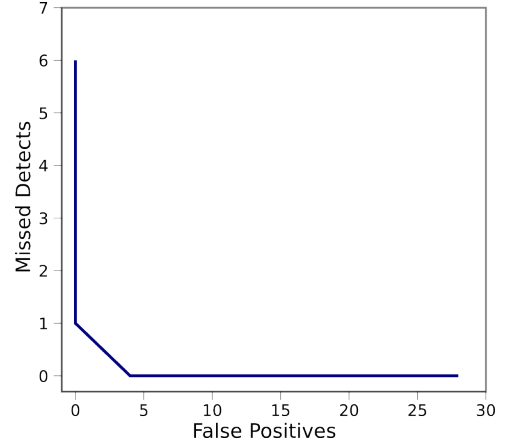
Figure 23: ROC curves for the Bailey and Robinson Run Mine datasets.

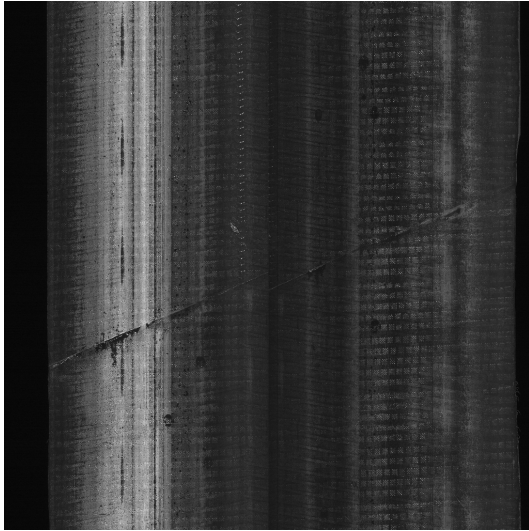
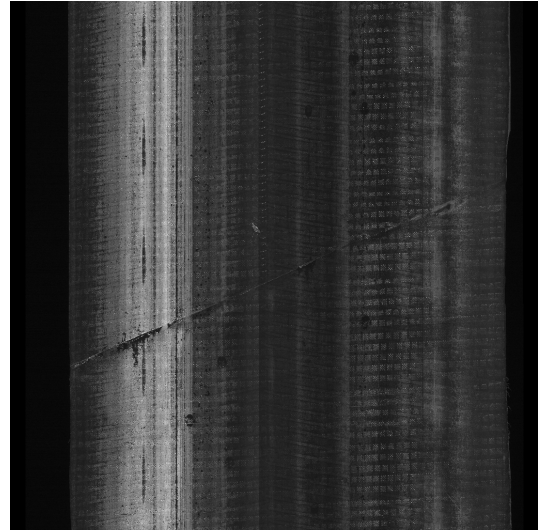
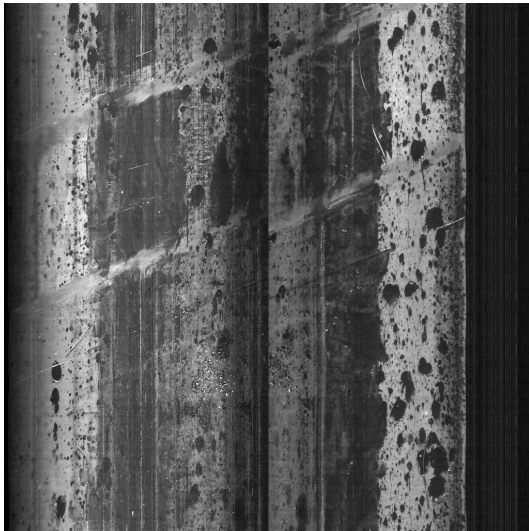
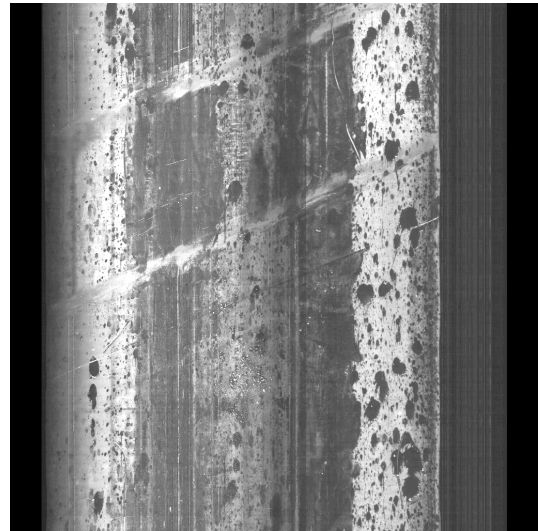
Figure 24: Belt images showing the effect of the new alignment algorithm. Contrast has been altered to make splice features more visible. (a) An image of a vulcanized splice from the from the Bailey mine without alignment. (b) The same image after alignment. (c) An image of a vulcanized splice from the Robinson Run mine without alignment. (d) The same image after alignment.
